**Region 9 Enforcement Division
75 Hawthorne Street
San Francisco, CA 94105
INSPECTION REPORT**

Inspection Date:	12/10/2015		
Time:	Entry: 8:00 a.m.	Exit: 11:00 a.m.	
Media:	Water		
Regulatory Program:	CWA NPDES/Industrial Storm Water		
Company Name:	Western States Packaging		
Facility or Site Name:	Western States Packaging		
Facility/Site Physical Location:	13276 Paxton Street		
(city, state, zip code)	Pacoima, CA 91331		
Geographic Coordinates:	34°16'35.91"N, 118°25'18.03"W		
Facility/Site Contact:	Dinh Nguyen	QA Manager	
	818-686-6045		
County:	Los Angeles County		
Company Contact:	Mark Pickrell	Vice President/CEO	
	818-686-6045		
Facility/Site Identifier:	CA WDID#: 4 1NEC000249		
NPDES Number:	CAS000001		
SWRCB Order Number:	2014-0057-DWQ		
SIC Code:	3089 – Plastics Products, Not Elsewhere Classified		
Facility/Site Personnel Participating in Inspection:			
Dinh Nguyen	QA Manager		
Inspector(s):			
Jared Richardson (Lead & Report Author)	PG Environmental, LLC	US EPA Contract Inspector	303-279-1778
Signature:

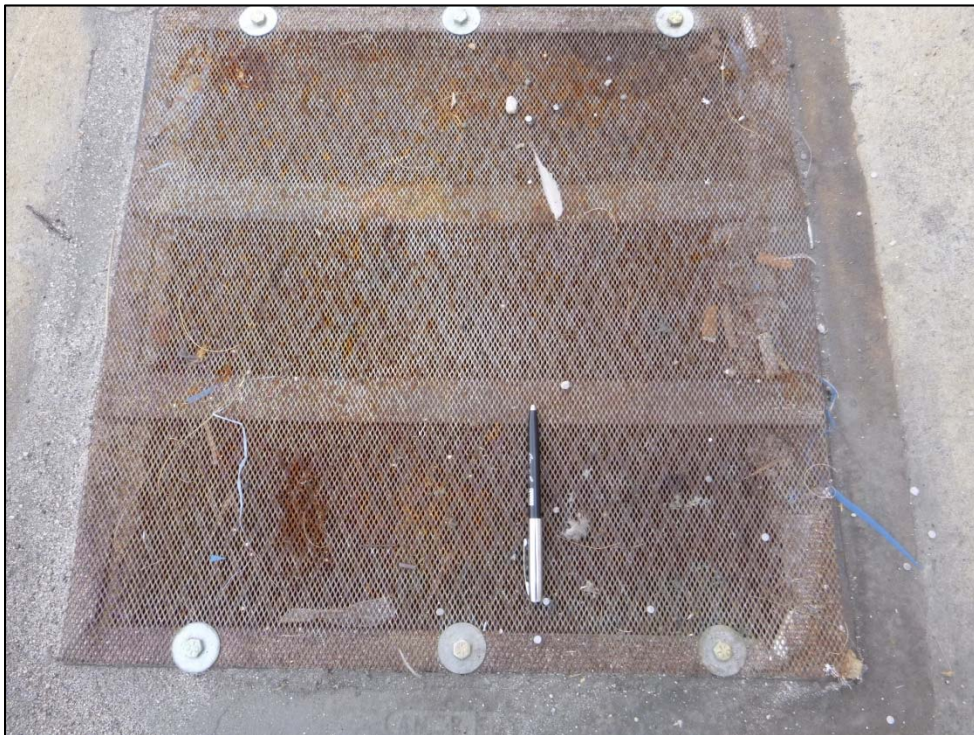
Photograph 2. View of 1mm mesh screen implemented by the Facility on one of the three storm drain inlets (DP-1, DP-2, and DP-3) located just south of the Facility building in the customer/employee parking lot.

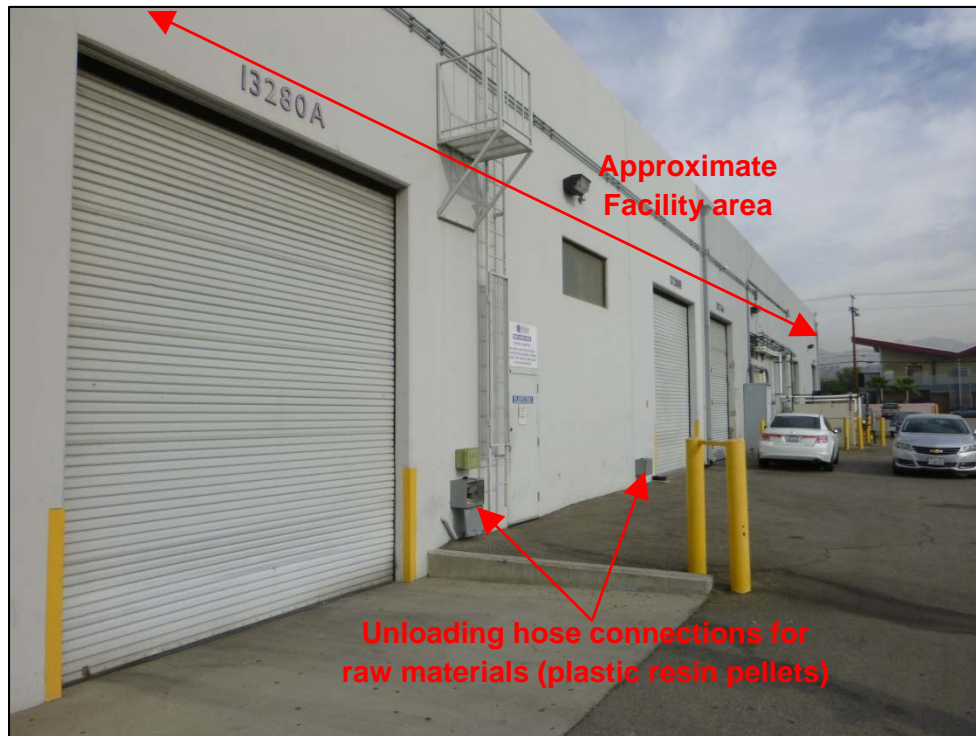
- d. We observed that the unloading hose connection transfer areas of raw materials (plastic resin pellets) and the trash and waste dumpster area were not depicted on the site map as required by Section X.E.3.f of the Permit. We observed two

unloading hose connection transfer areas (Photographs 3 and 6), and two dumpsters one of which was uncovered at the Facility (Photographs 4 and 14).

Photograph 3. View of approximate extents of Facility building area. Note the location of the hose connections for the unloading of raw materials (plastic resin pellets).

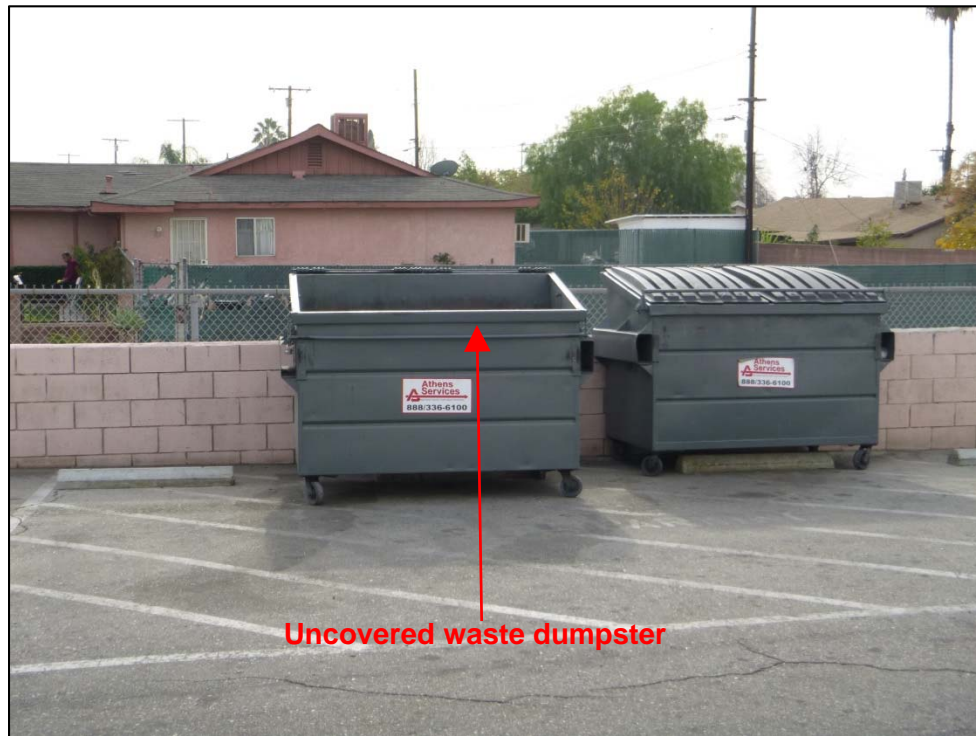
Waste treatment/disposal areas	No	We observed that the trash and waste dumpster area located south of the Facility was not identified on the site map (Photographs 4 and 14).
Dust or particulate generation areas	NA	
Cleaning and material reuse areas	NA	
Other areas of industrial activities	NA

Photograph 4. View of trash and waste dumpster area located just south of bay 13280A. Note the uncovered waste dumpster.

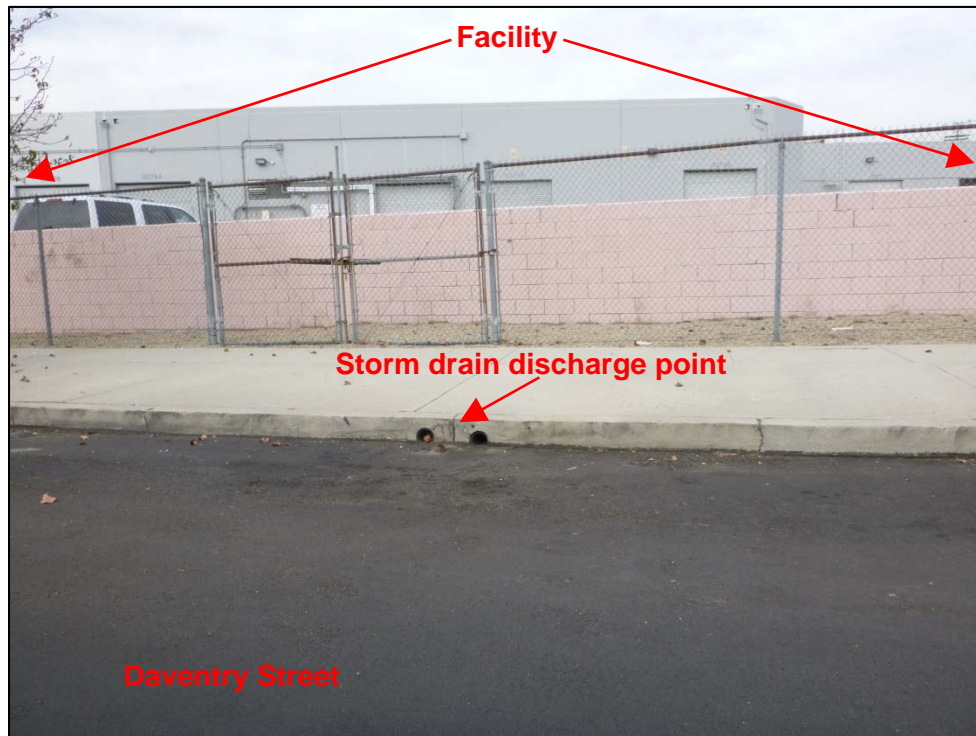
- c. We observed that the municipal storm water conveyances and drains which may receive Facility storm water discharges were not depicted on the site map as required by Section X.E.3.a of the Permit. We observed a Facility storm water runoff discharge point to Daventry Street (Photograph 5).

Photograph 5. View of storm drain inlets (DP-1, DP-2, and DP-3) discharge point onto Daventry Street located south of the Facility.

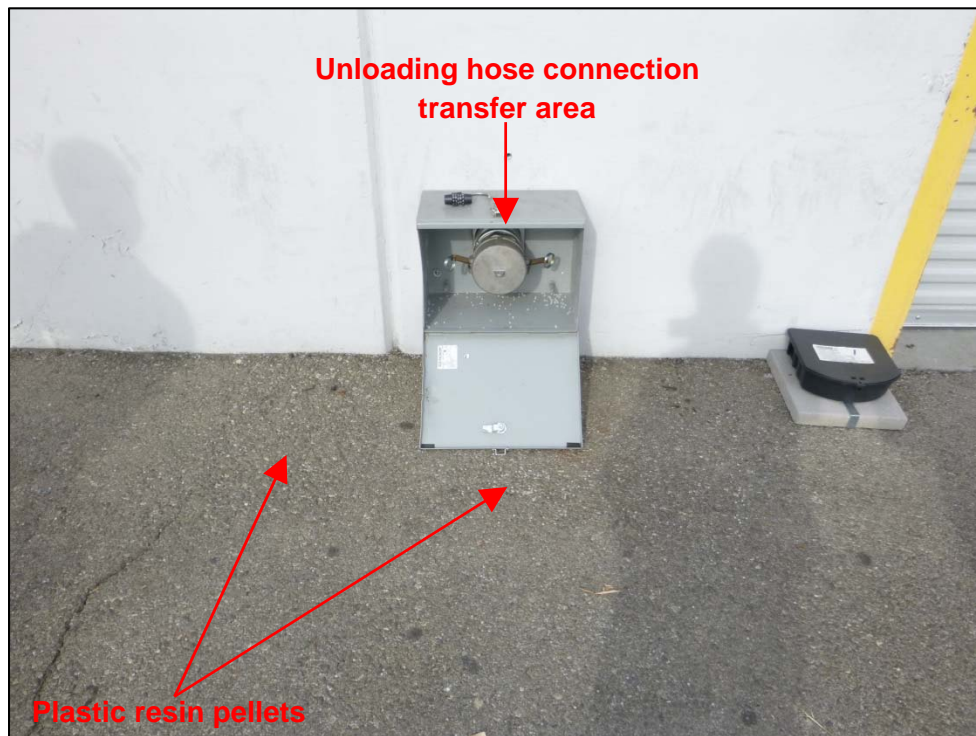
Photograph 6. View of unloading hose connection transfer area for raw materials (plastic resin pellets) to the Facility located adjacent to bay door 13280B. Note the plastic resin pellets scattered about on the impervious area exposed to storm water.

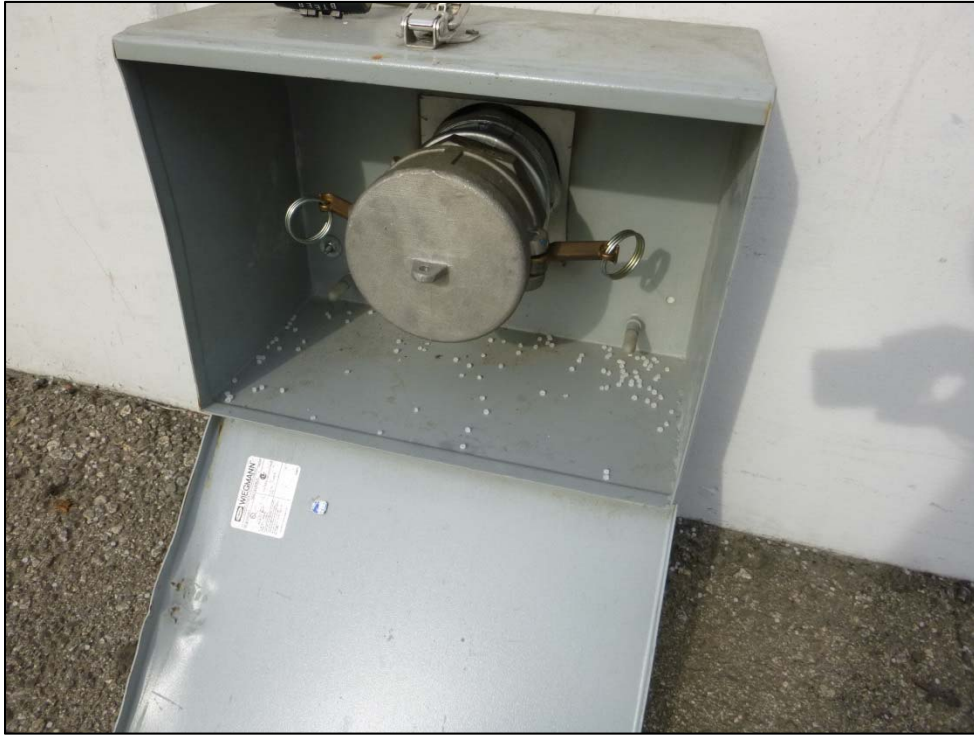
Photograph 7. Close-up view of the hose connection transfer area shown in Photograph 6.

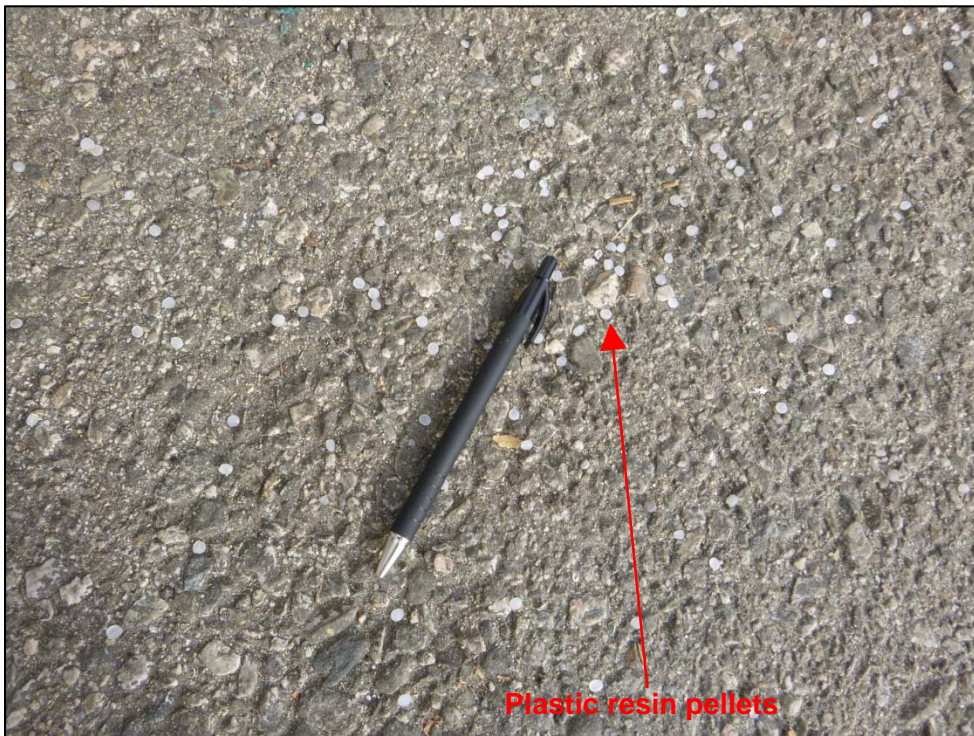
Photograph 8. Close-up view of the Facility raw materials (plastic resin pellets) on the impervious surface adjacent to the hose connection transfer area shown in Photograph 6.

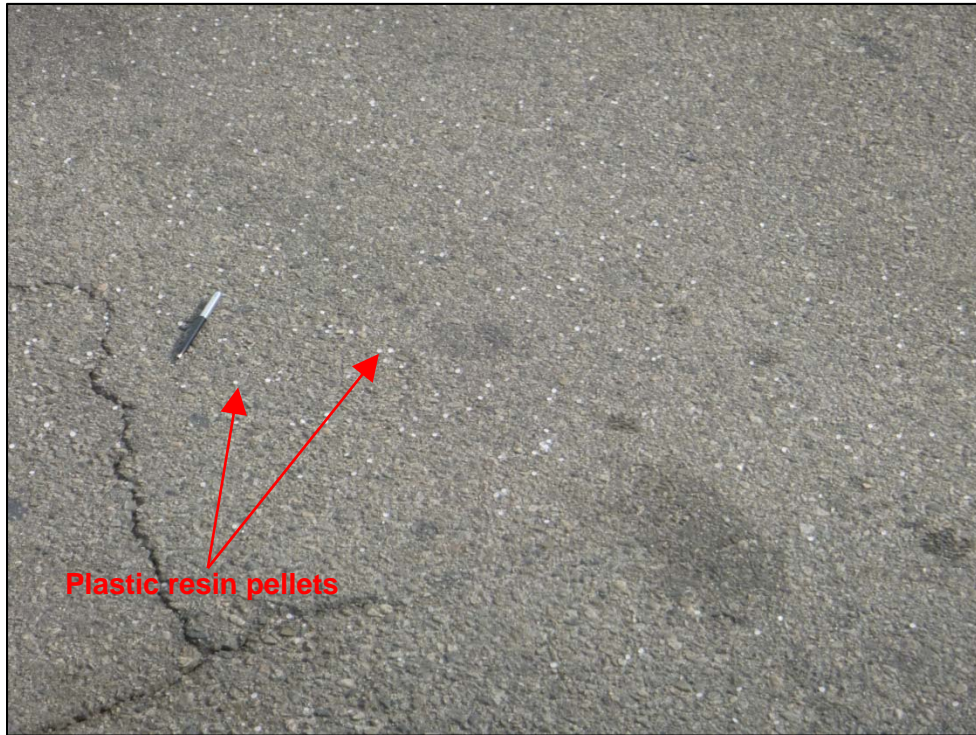
Photograph 9. View of raw materials (plastic resin pellets) scattered about the impervious surfaces downgradient of the Facility building in the customer/employee parking area.

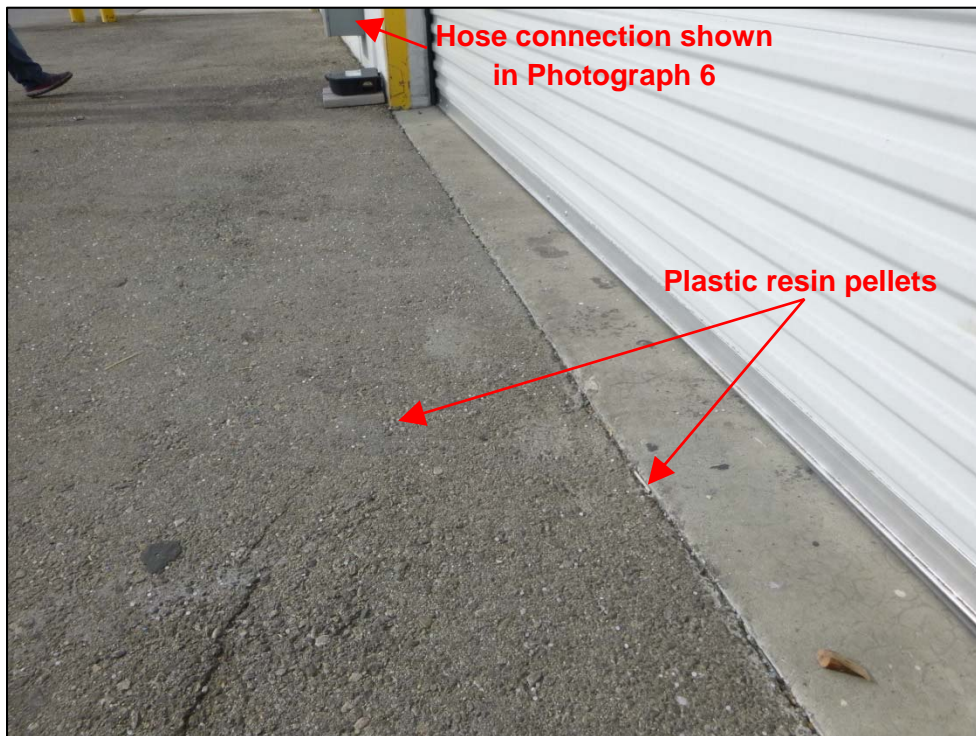
Photograph 10. View of raw materials (plastic resin pellets) on the impervious surfaces adjacent to Facility bay door 13280A.

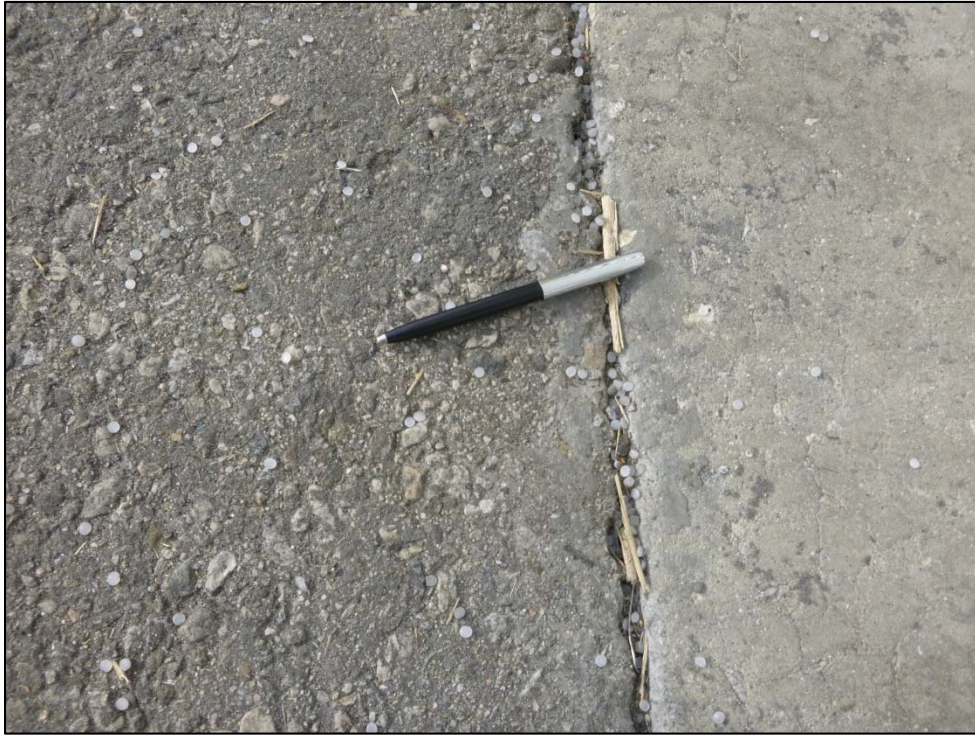
Photograph 11. Close-up view of plastic resin pellets on the impervious surface adjacent to Facility bay door 13280A, shown in Photograph 11.

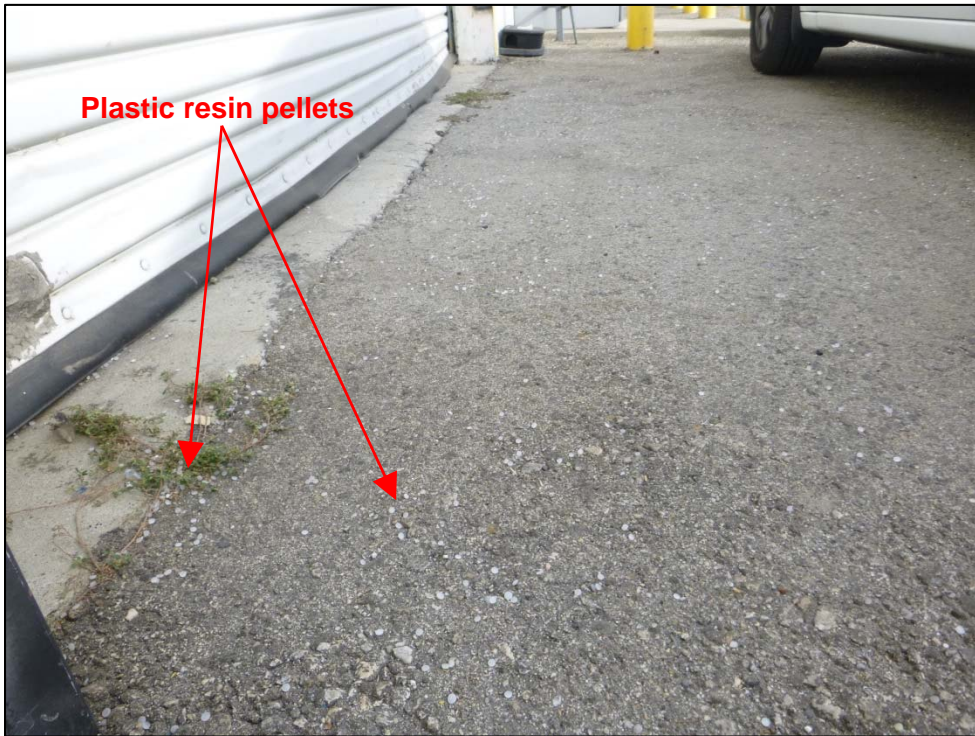
Photograph 12. View of raw materials (plastic resin pellets) on the impervious surface adjacent to the Facility bay door 13276A.

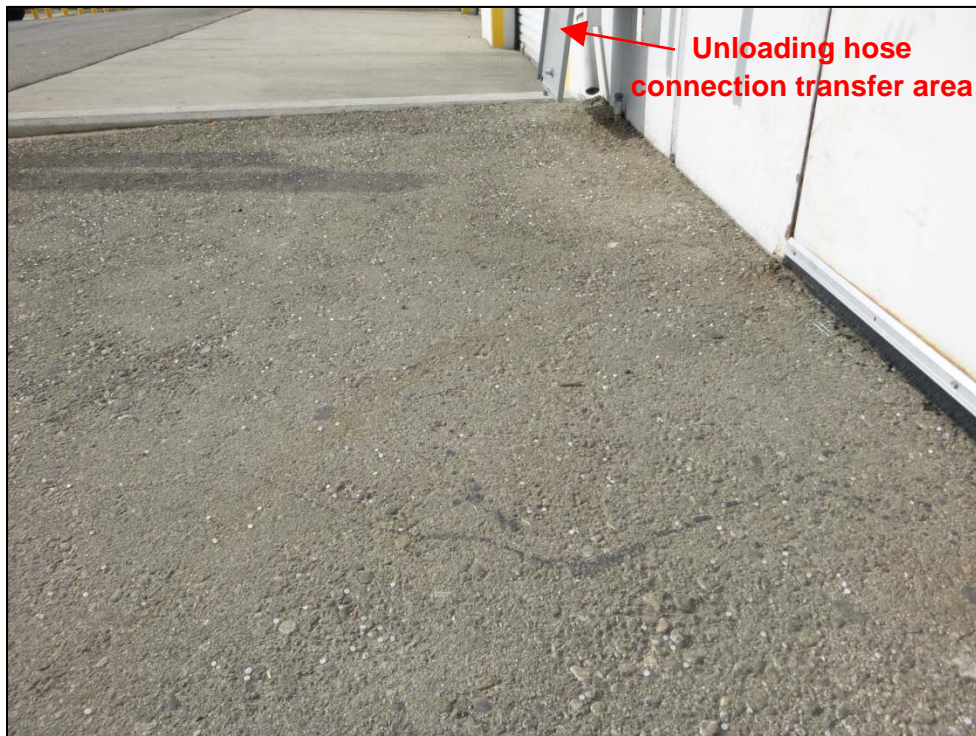
Photograph 13. View of raw materials (plastic resin pellets) on the impervious surface adjacent to the unloading hose connection transfer area at Facility bay door 13280A.

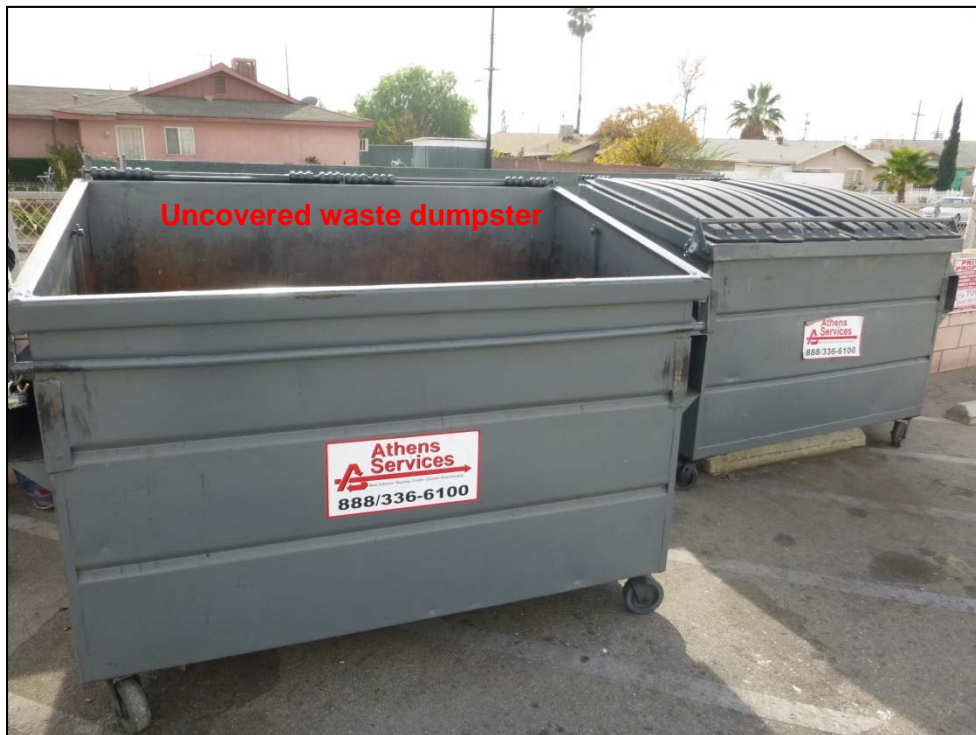
Photograph 14. View of uncovered trash and waste dumpster located along the southern perimeter of the customer/employee parking area.

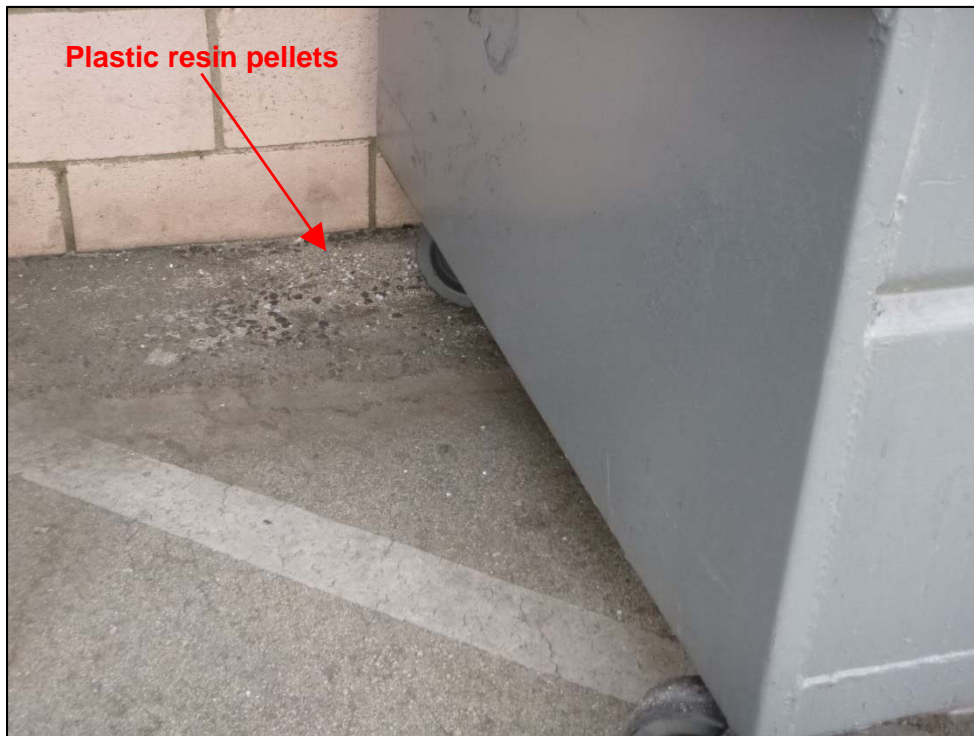
Photograph 15. View of raw materials (plastic resin pellets) on the impervious surface beneath the dumpster, shown in Photograph 14.

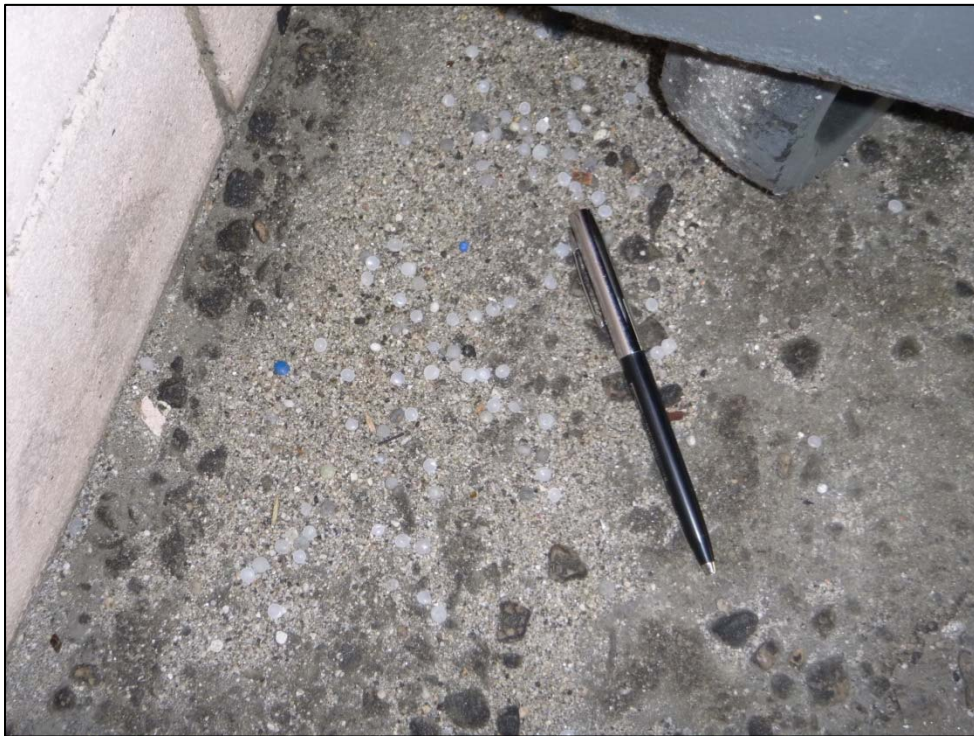
Photograph 16. Close-up view of the plastic resin pellets on the impervious surface, shown in Photograph 15.

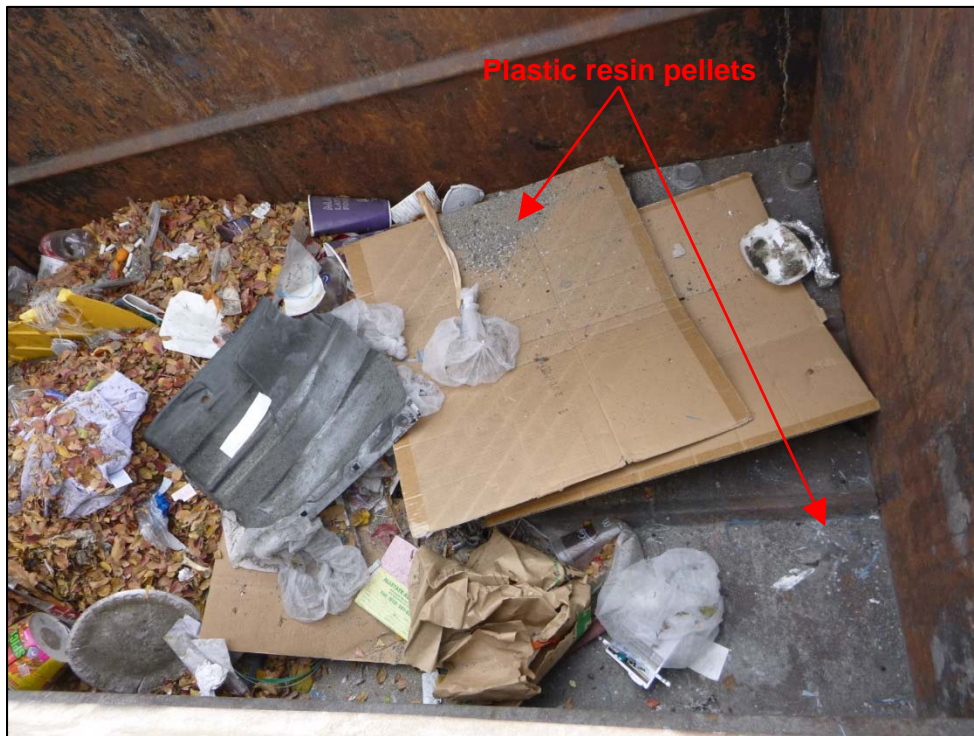
Photograph 17. View of the contents of the uncovered waste dumpster shown in Photograph 14. Note the raw materials (plastic resin pellets) within the dumpster.

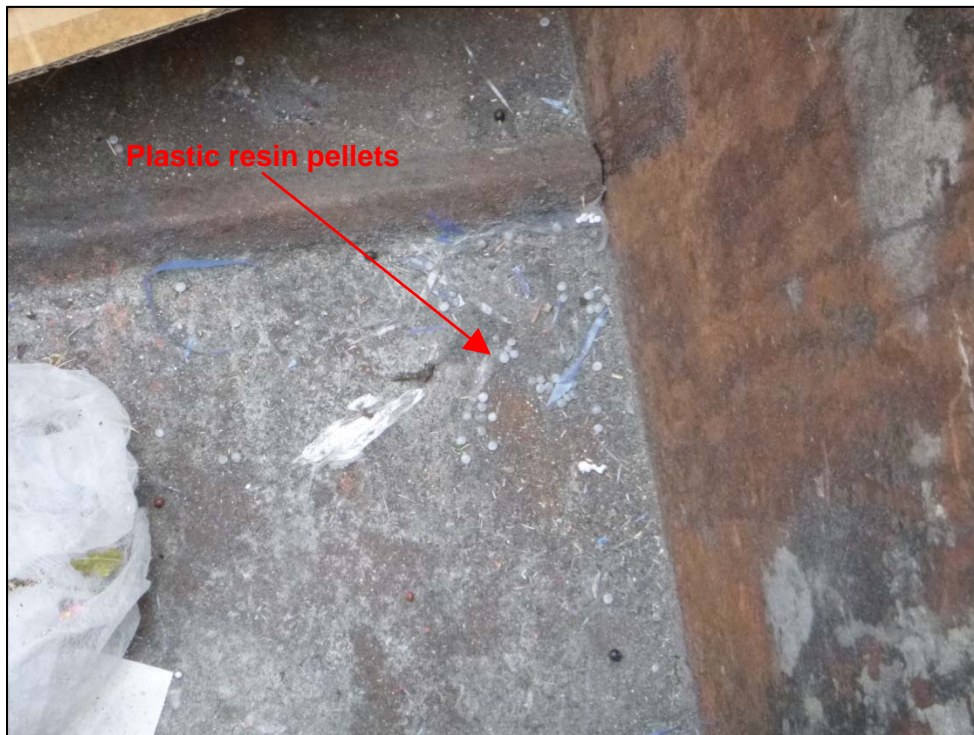
Photograph 18. Close-up view of the plastic resin pellets in the uncovered waste dumpster, shown in Photograph 17.

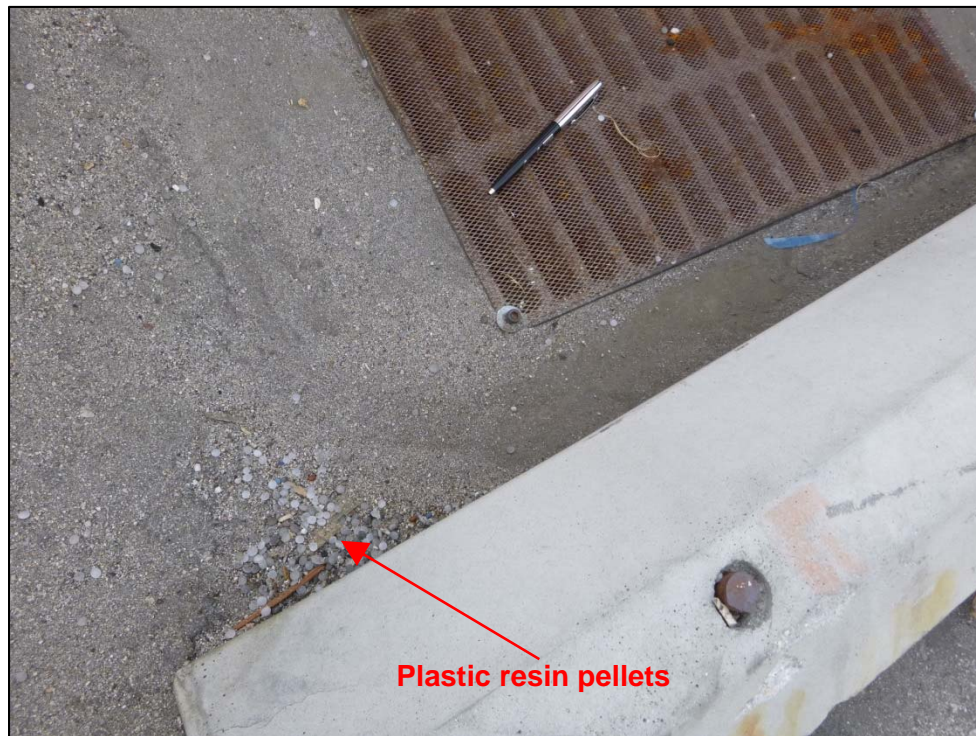
Photograph 19. View of raw materials (plastic resin pellets) adjacent to the storm drain inlet downgradient of the Facility building along the south side of the customer/employee parking area.

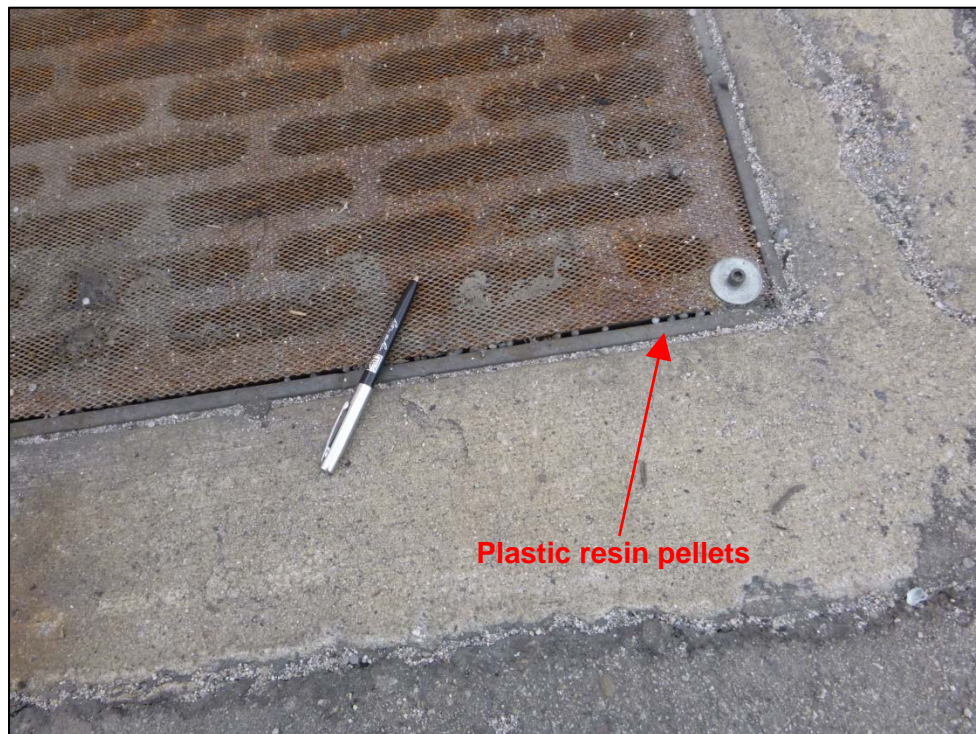
Photograph 20. View of plastic resin pellets on the storm drain inlet grate.

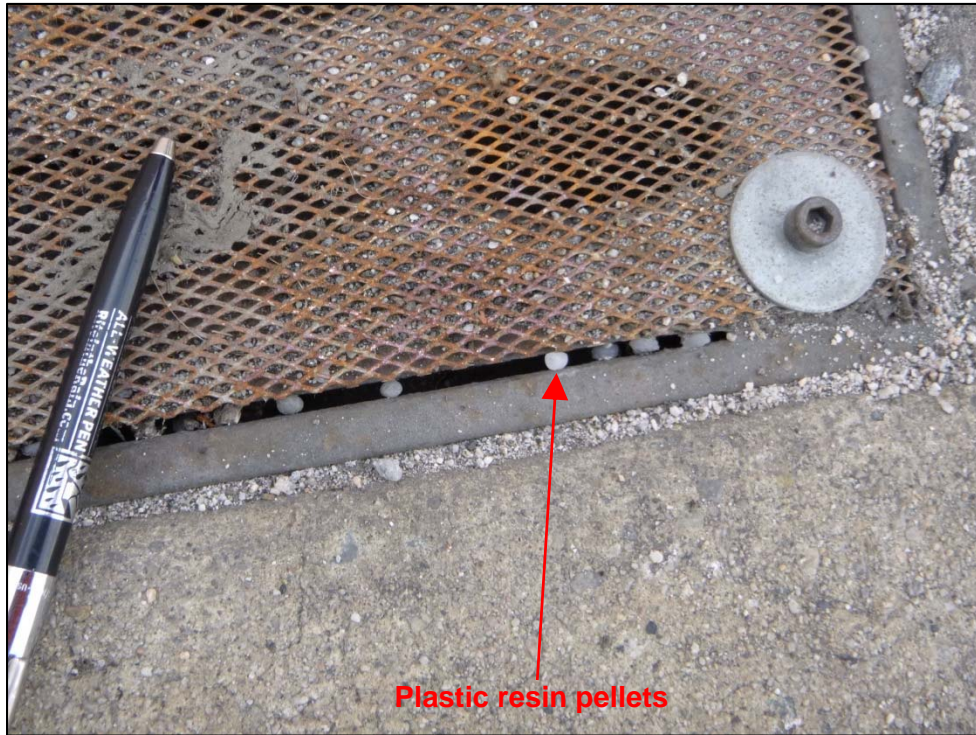
Photograph 21. Close-up view of the plastic resin pellets on the storm drain inlet grate.
